Pioneer Natural Resources 10 Year “Best Practices” Program

Pioneer Natural Resources 10 year “Best Practices” program

By ALBERT S. GARZA, Pioneer Natural Resources USA, Inc.
DANNY HERNANDEZ, Pioneer Natural Resources USA, Inc.
SCOTT W. LONG, Flexbar, Inc.

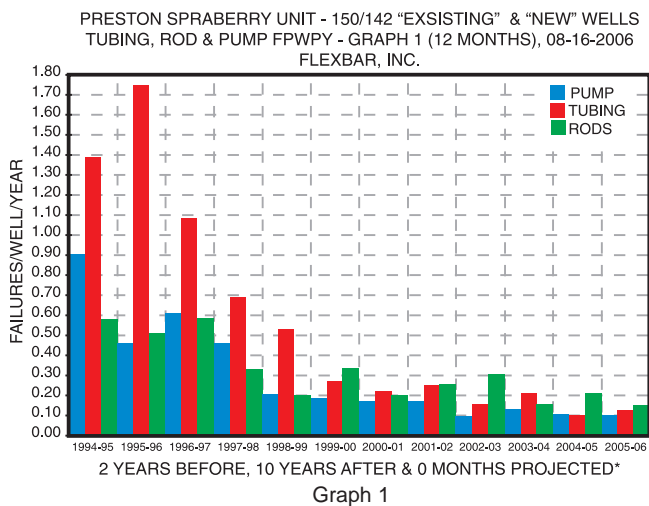
The 10-year Performance (failures per well per year – FPWPY) for this 150 well, PSU “Best Practices” program is displayed in **Graph 1** and is listed below:

Tubing Leaks	94% Reduction
Rod Failures	75% Reduction
Pump Failures	80% Reduction
Total Failures	88% Reduction

The 10-year performance for this PSU “Best Practices” 150 well project utilizing 2006 failure costs of \$16,000 per tubing leak; \$9,000 per rod failure; and \$8,000 per pump failure is estimated at \$17.9 million savings in downhole failures. This is an average savings in downhole failures of \$1.8 million per year.

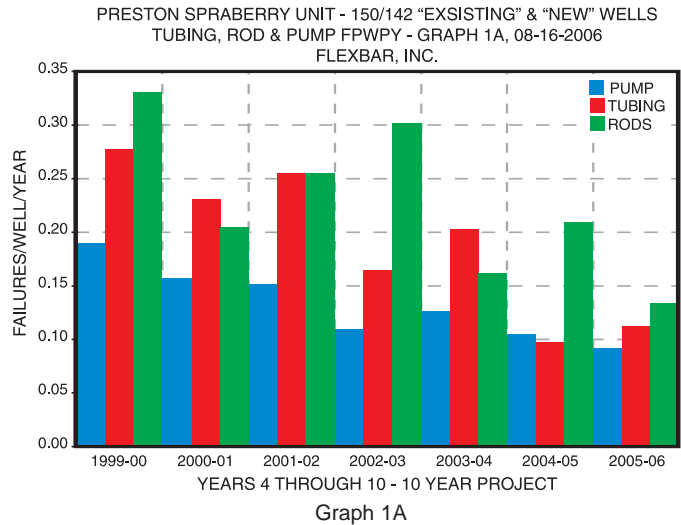
While 71 percent of the reduction in total failures occurred during the first four years of this program, there was still a 58 percent reduction in total failures during years 4 through 10. Refer to **Graph 1A**.

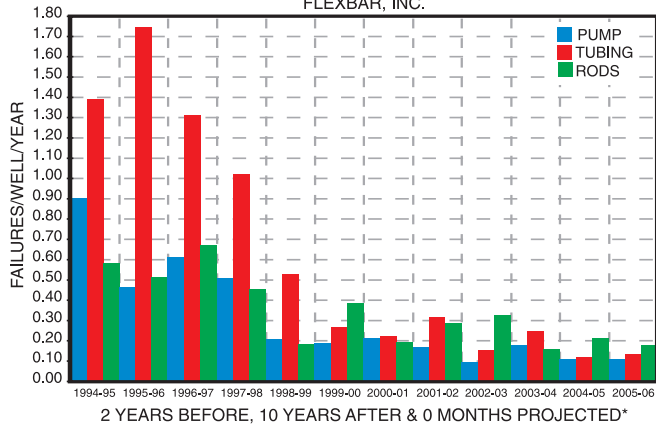
Graph 2

PRESTON SPRABERRY UNIT - 87/85 "EXISTING" WELLS
TUBING, ROD & PUMP FPWPY - GRAPH 2 (12 MONTHS), 08-16-2006
FLEXBAR, INC.

The 10 year failure reduction performance (FPWPY) of the 87 existing wells is displayed in **Graph 2** and is listed below:

<u>95-96</u>	<u>05-06</u>	
Tubing Leaks	1.75	0.13	93% Reduction
Rod Failures	0.52	0.18	65% Reduction
<u>Pump Failures</u>	<u>0.46</u>	<u>0.11</u>	<u>76% Reduction</u>
Total Failures	2.73	0.42	85 % Reduction

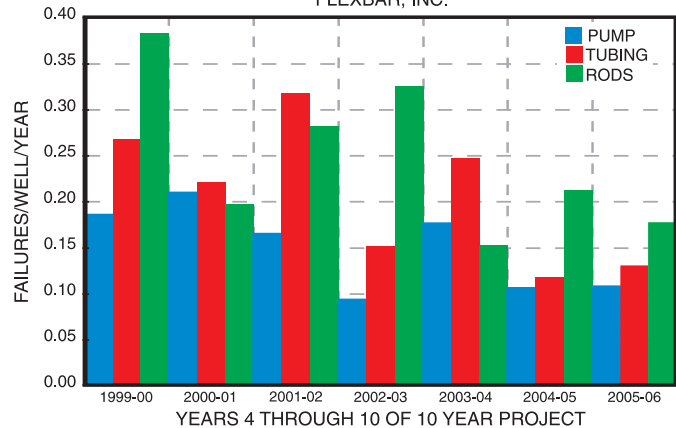
Graph 2A

PRESTON SPRABERRY UNIT - 87/85 "EXISTING" WELLS
TUBING, ROD & PUMP FPWPY - GRAPH 2A, 08-16-2006
FLEXBAR, INC.

While the majority (69%) of the reduction in total failures for these 87 existing wells occurred during the first four years of this program, there was still a significant reduction (50%) in total failures during years 4 through 10. Refer to **Graph 2A**.
